# Manhole Inspection Summary

Manhole # S23WW1002MH

Insp Date: **2/21/07 2:01 PM**

**Location** Address: **301 EDGEVALE RD**

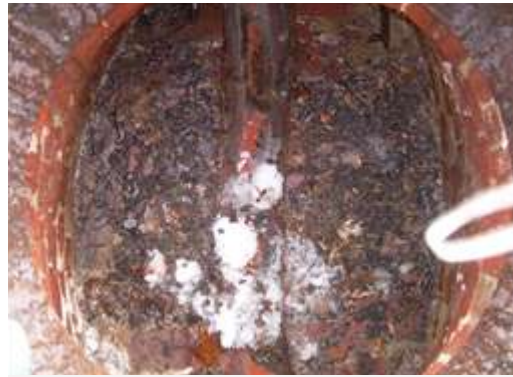
Top View

Barrel infiltration. Evidence of surcharge - Bench debris. Channel debris.

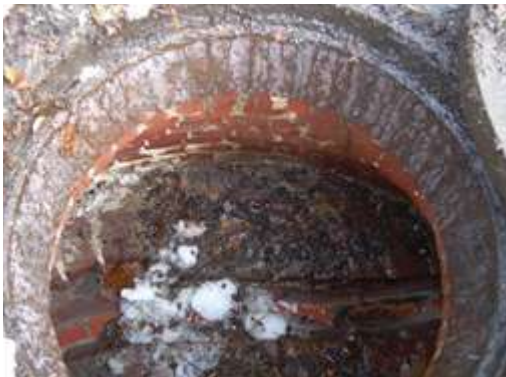
Defect

Corbel and Barrel infiltration.

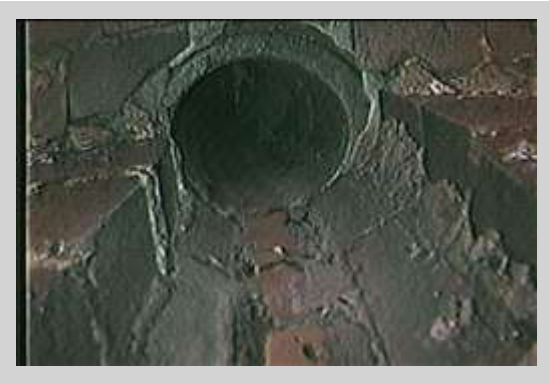
### 6 in. Circular Gravity Sewer Pipe Out @ 12 O'Clock

Barrel deterioration and infiltration.

Infiltration: **Evidence** Pipe Seal Cond: **Cracked**

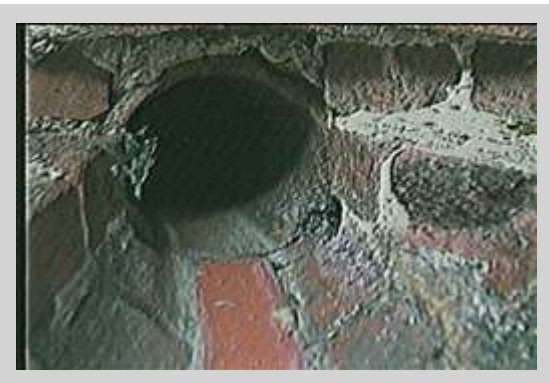
### 6 in. Circular Gravity Sewer Pipe In @ 5 O'Clock

Channel deterioration.
